Fatigue Evaluation of the
Deck Truss of Bridge 9340

FATIGUE EVALUATION OF THE DECK TRUSS OF BRIDGE 9340

Final Report

March 2001

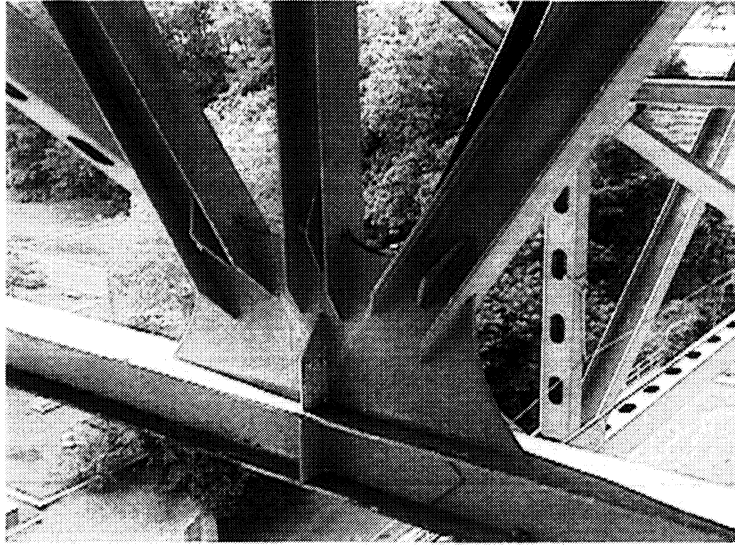
Figure 5: Welded Attachment at Interior of Box Section of Main Truss

The built-up box sections have attachments measuring 8.9 cm square welded to diaphragms at the interior of all tension members (Figure 5). There are also intermittent fillet welds at the interior of all box sections. These are both Category D details. The floor truss members have longitudinal stiffeners measuring 30.5 cm, which would be considered a Category E detail (Figure 6).

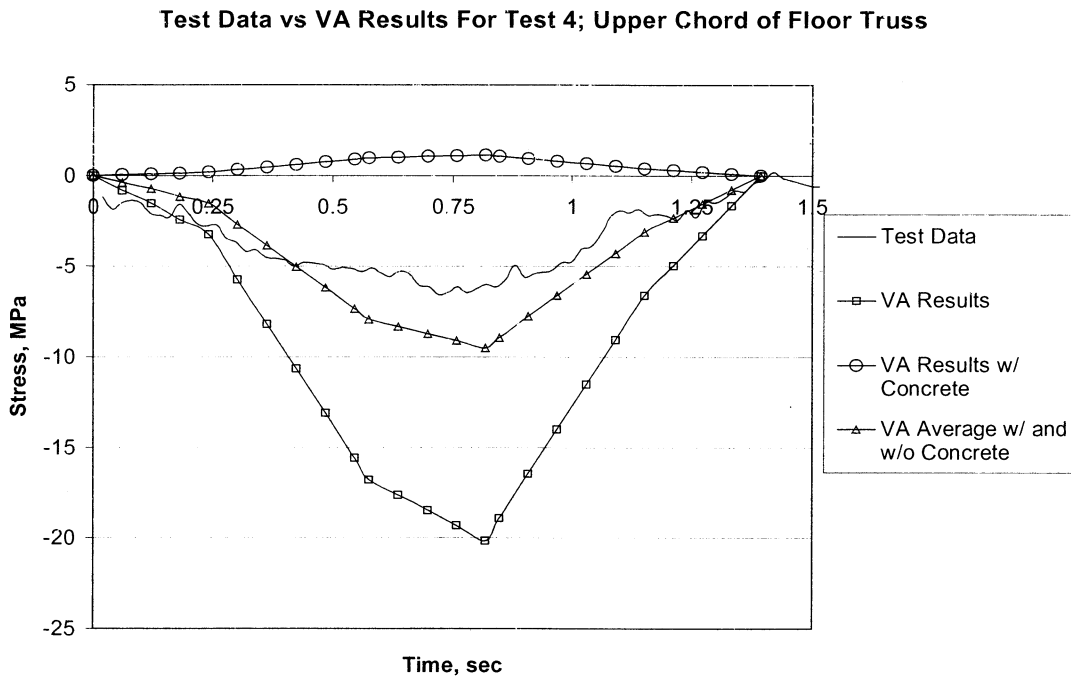
A

Test Data vs VA Results For Test 4; Diagonal of Floor Truss

From these figures, it can be seen that the analysis results from the upper chord and lower chord without the concrete deck in place are much higher than

the recorded stresses. Including the deck lowers the stresses too much so the two separate predicted responses were averaged to estimate the contribution of the concrete deck. This averaged predicted response shows the best correlation to the actual response. The ratio of actual to predicted stress ranges is shown in Table 16.

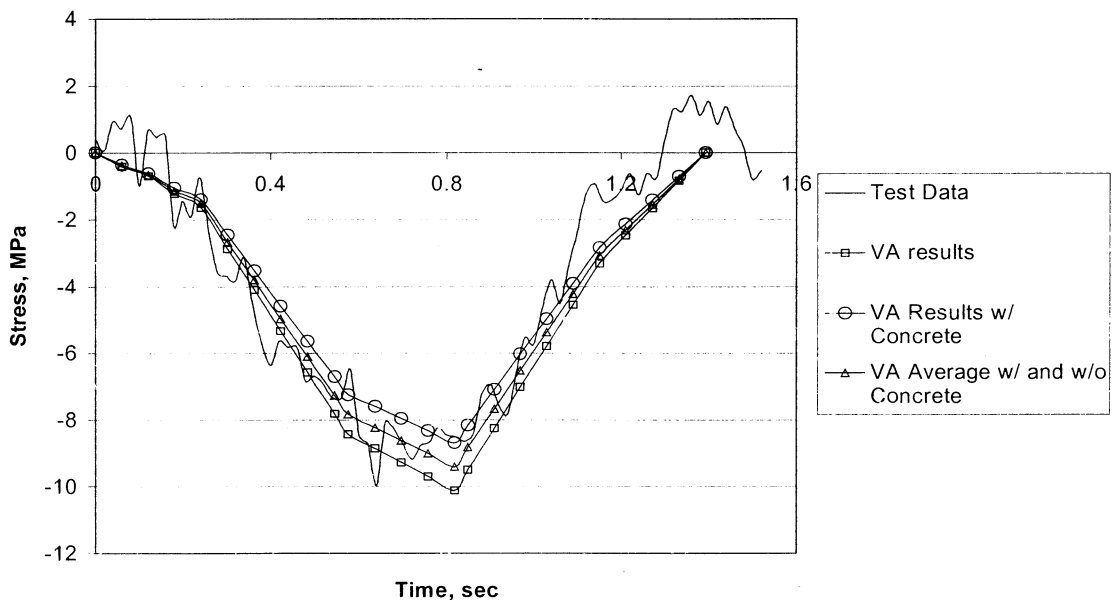
B

Test Data vs VA Results For Test 4; Lower Chord of Floor Truss

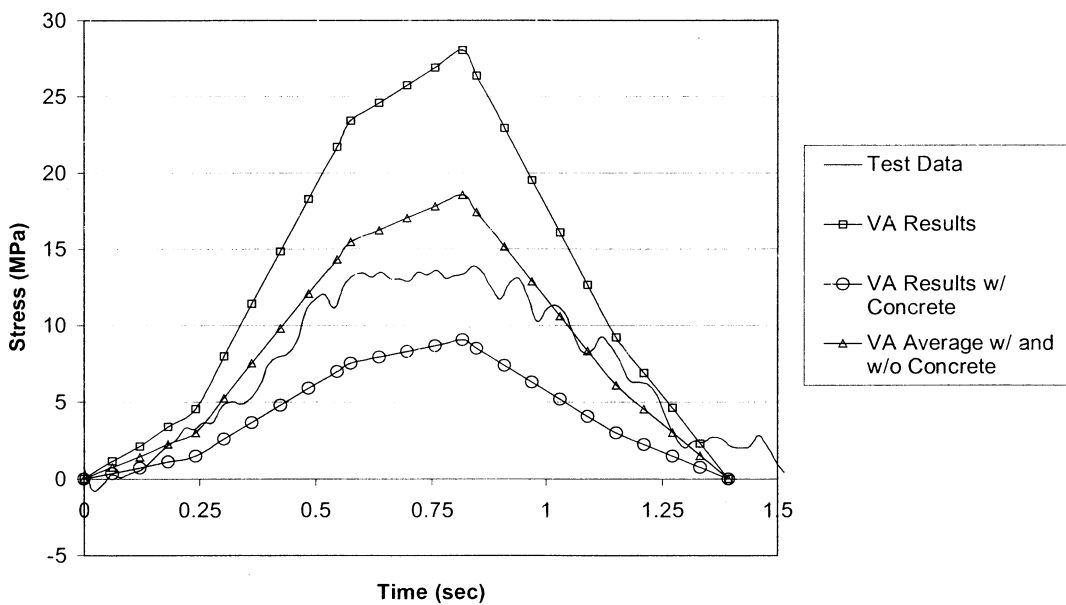
C

Figure 24: Comparison of 2-D Analysis and Test Data for Floor Truss in Test 4
